(6) National Dam Inspection Program.  
Number  
**DOVERSPIKE NO. 2 DAM**  
(NDI I.D. PA-00810,  
DER I.D. 33-57), Ohio River basin,  
Caylor Run, Jefferson County,  
Pennsylvania.  
**PHASE I INSPECTION REPORT,**  
**NATIONAL DAM INSPECTION PROGRAM**

NAME OF DAM: Doverspike No. 2 Dam  
STATE LOCATED: Pennsylvania  
COUNTY LOCATED: Jefferson  
STREAM: Caylor Run, Tertiary Tributary of Mahoning Creek  
SIZE CLASSIFICATION: Intermediate  
HAZARD CLASSIFICATION: Significant  
OWNER: J. C. Enterprises  
DATE OF INSPECTION: April 24, 1980 and May 1, 1980

DOVERSPIKE NO. 1 DAM  
NDI I.D. PA-810  
DER I.D. 33-57  
APRIL 24, 1980

PHASE I REPORT  
NATIONAL DAM INSPECTION PROGRAM  
DOVERSPIKE NO. 2. DAM  
NDI I.D. PA-810  
DER I.D. 33-57

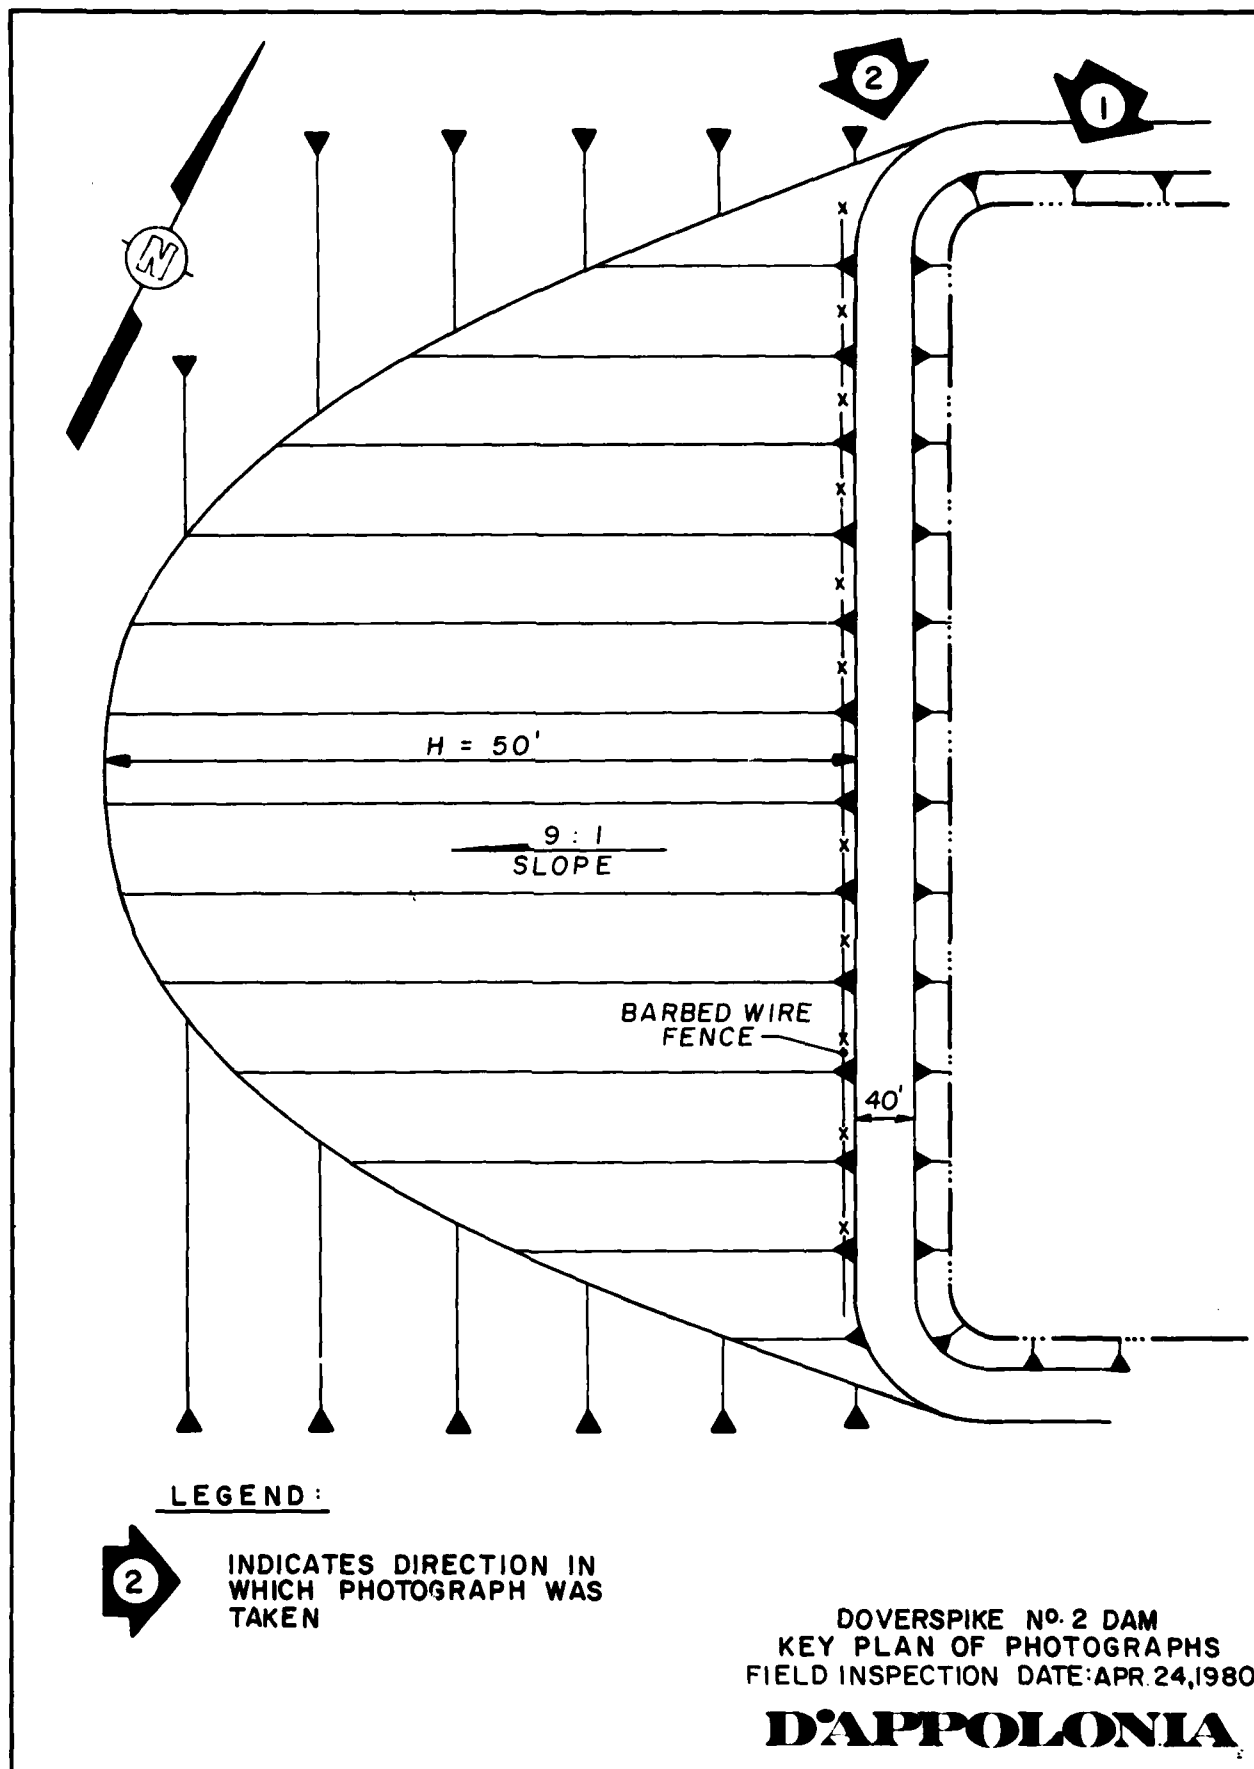
Photograph No. 1  
Upstream face (looking south).

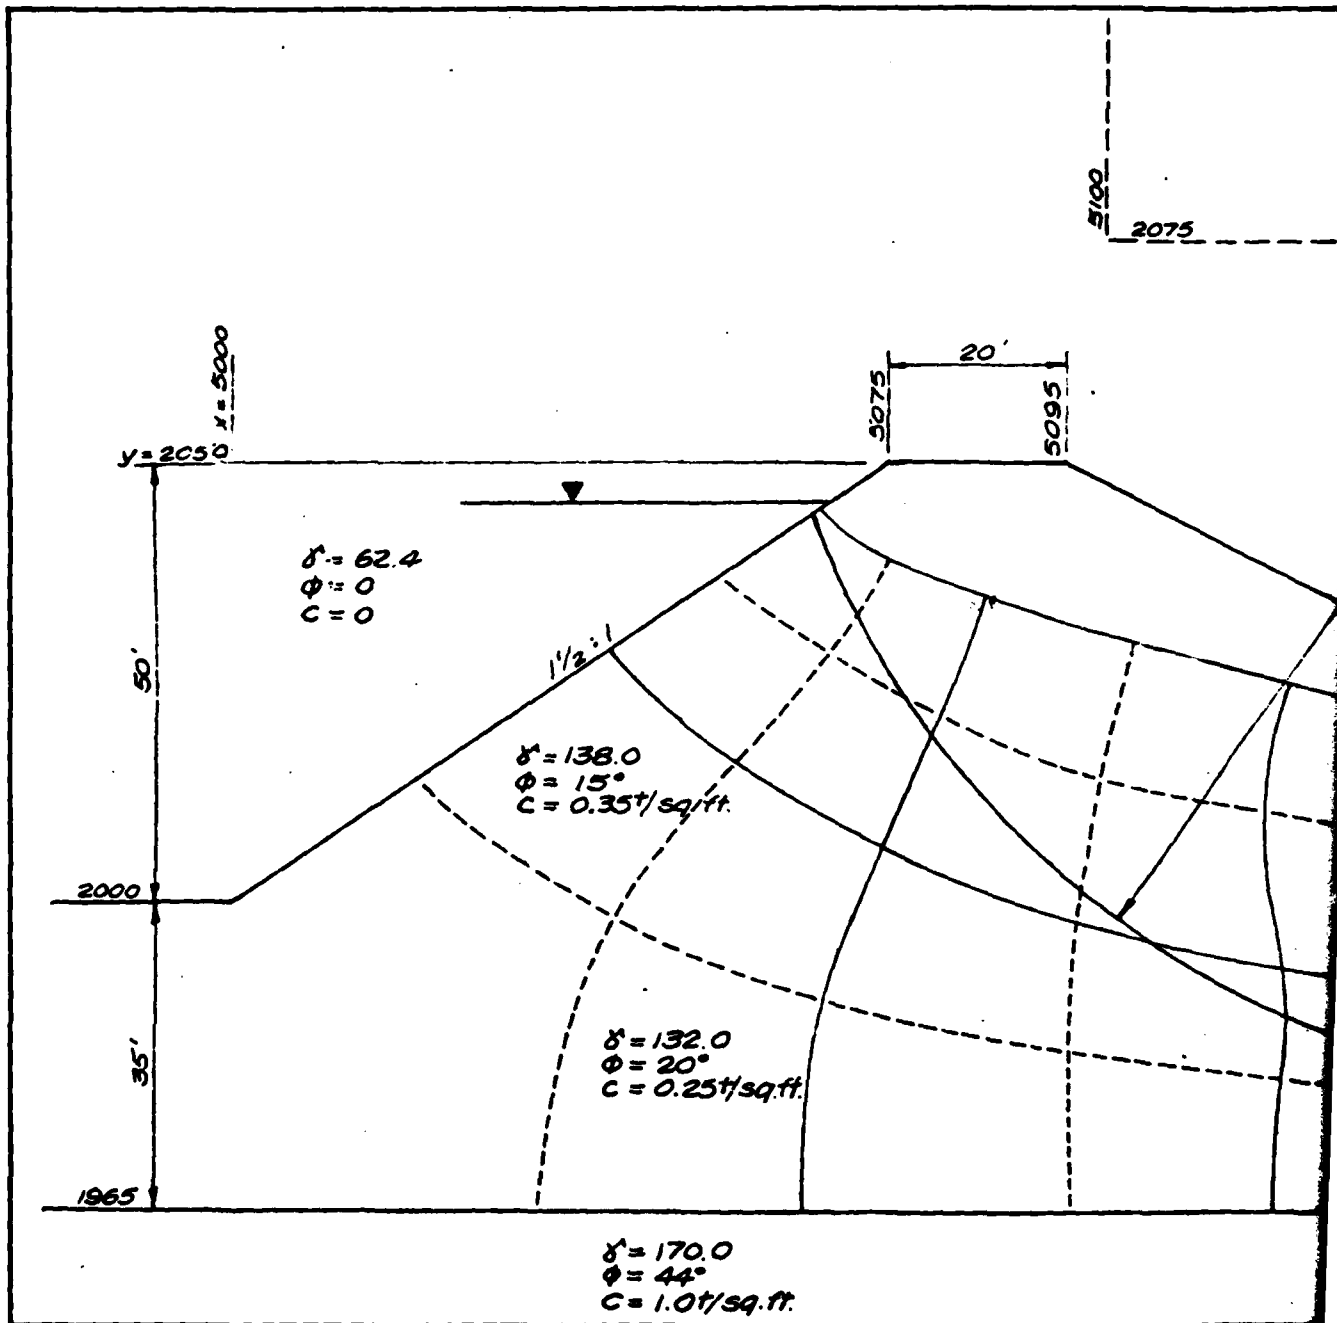
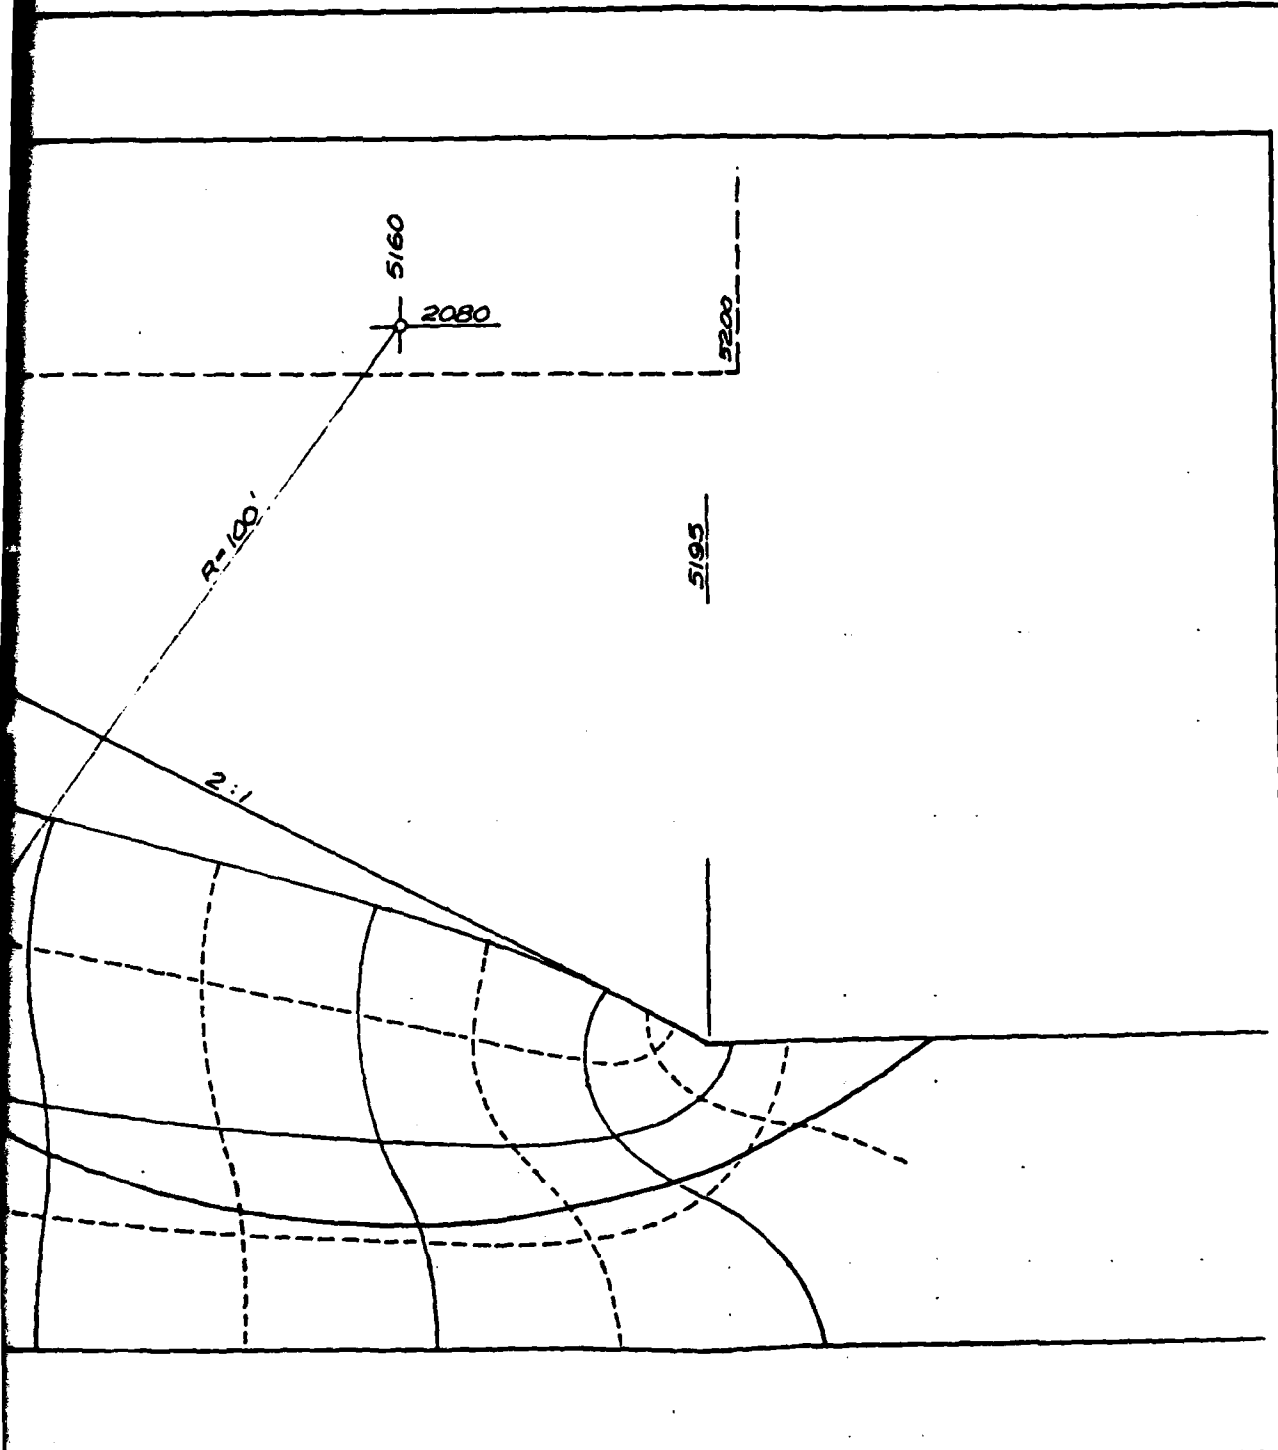
PLATE 2

(1) Embankment. The visual observations indicate that the typical cross section of the embankment had been significantly modified during construction. The proposed dam, as shown in Plate 2, consisted of a homogeneous embankment with a 2H to 1V downstream slope, a 1.5H to 1V upstream slope, and a crest width of 20 feet. Presently, the downstream slope is approximately 9H to 1V and the crest is about 40 feet wide. The design of the proposed embankment consisted of subsurface investigation, laboratory and materials testing, and engineering analysis. The slope stability factor of safety of the proposed dam was reported to be in the range of 1.4 to 1.5. Based on visual observations, the static stability of the existing embankment is considered to be adequate.
